Selectroicide™ Chlorine Dioxide as a New Product for the Control of Algae and Other Microbial Pests in Greenhouse Irrigation Systems®

Peter Konjoian

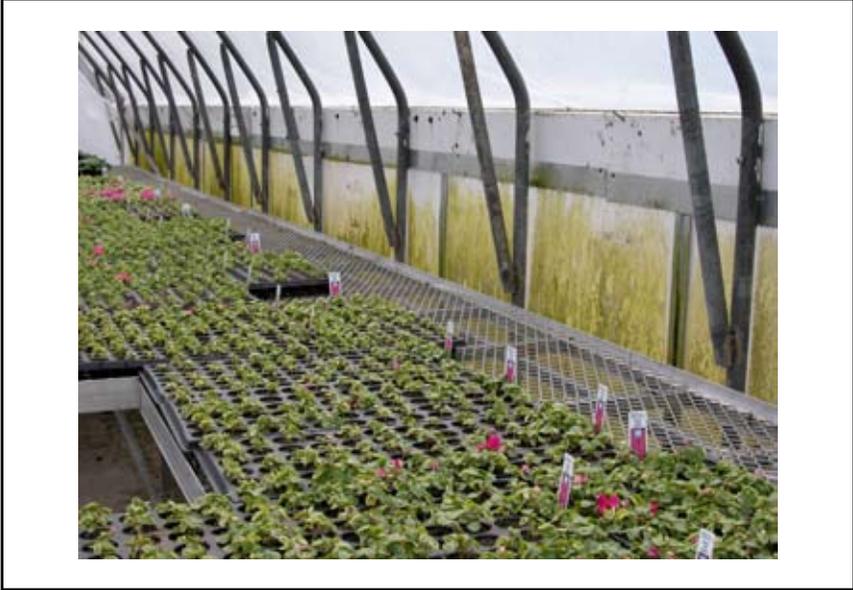
Algae cause a number of problems relating to greenhouse management. It forms on sidewalls of the greenhouse, particularly when plants are grown close enough for fertilizer solution to splash, drip, or drain onto the glazing material (Fig. 1). The advanced stage of development reduces light transmission through the sidewall and growth of plants in the immediate vicinity. It is viewed by many as a nuisance and can lead customers to form a negative impression of the operation by suggesting that cleanliness and good sanitation practices are not priorities.

Figure 1. Algae forming on greenhouse sidewalls.

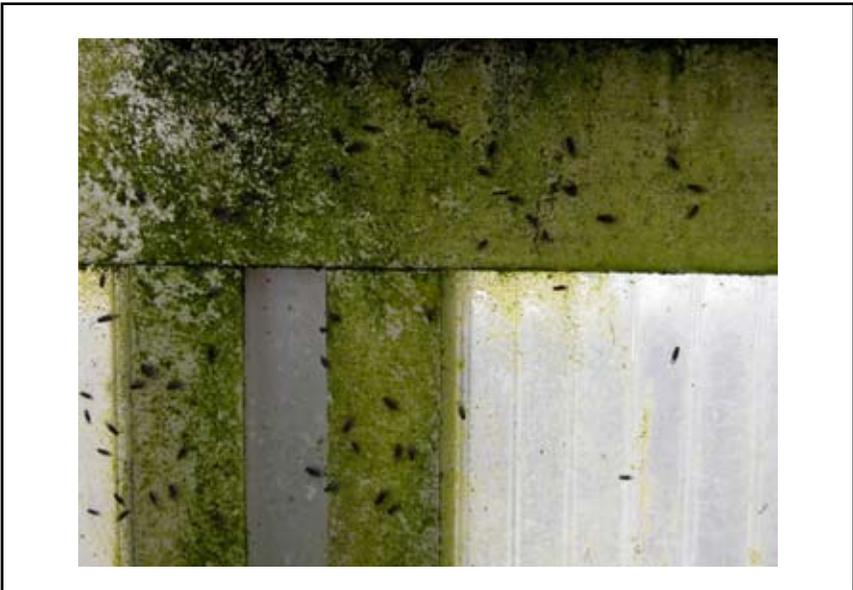
Its presence is known to provide feeding and breeding areas for insects such as fungus gnats and shore flies (Fig. 2). Populations of these insects are known to vector plant diseases, particularly those that occur in the growing medium. A shore fly population, if present in a retail area, can be quite distracting and cause shoppers to question whether the "bugs" are going to harm the plants they purchase. Until recently we responded by saying shore flies were only nuisance pests and would not harm plants. Research has shown otherwise, and shore flies are now known to spread diseases in the same way that fungus gnats do.

Figure 2. Algae provides feeding and breeding areas for insects.

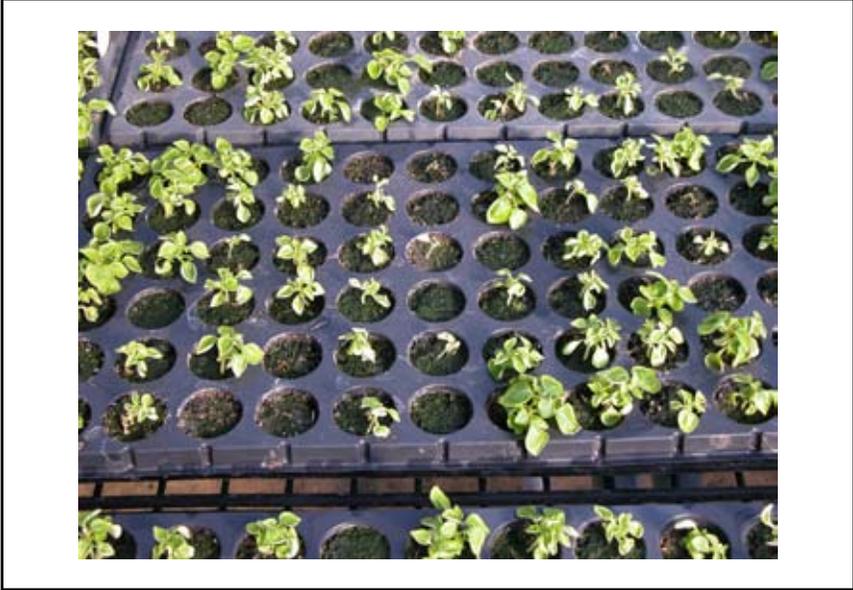
Algae cause direct crop loss when present on the growing medium surface of seedling plugs (Fig. 3). Young, tender seedlings are negatively affected as advanced algae development results in loss of crop uniformity and forces compromised growing decisions. If the larger seedlings are dry yet the smaller seedlings are not, should the plug tray be watered? If a chemical growth regulator application is scheduled, when should the tray be treated? Regardless of the decisions, some plants will either be over-watered or under-watered and receive too much plant growth regulator or not enough. At some point, the additional expense of hand labor becomes necessary to grade the plants prior to use.

Figure 3. Algae on growing medium surface causes crop problems.

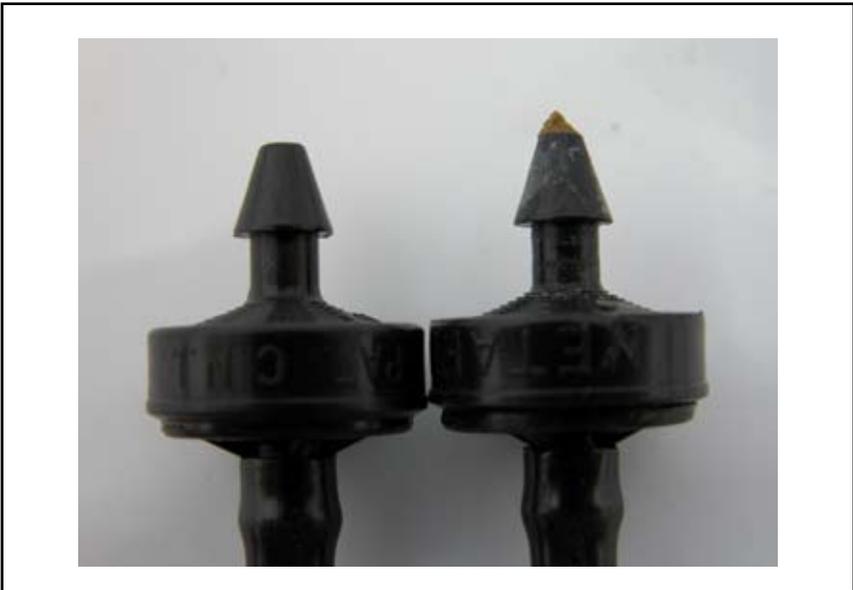
Algae can clog drip emitters (Fig. 4), mist nozzles and water breakers, solenoid valves, and other parts of irrigation systems. Discussions with growers repeatedly touch on the following cost associated with algae. Clogged drip tubes, particularly those used for hanging baskets, cause significant concern and crop loss. Not only do drip emitters need to be replaced after failing, but more often than not, the

Figure 4. Algae and biofilm cause clogging of drip emitters. New emitter on left, clogged on right.

Before ending this issue, take a look at the two drip emitters pictured in Fig. 4. On the right is an emitter I removed from a hanging basket drip line after finding it had failed. Note the accumulation of biofilm at the tip, which has plugged the emitter. We analyzed the plug and have confirmed that it is not particulate matter that passed through my filter but, rather, biofilm and algae that have become established inside the line. On the left is a new emitter for comparison.

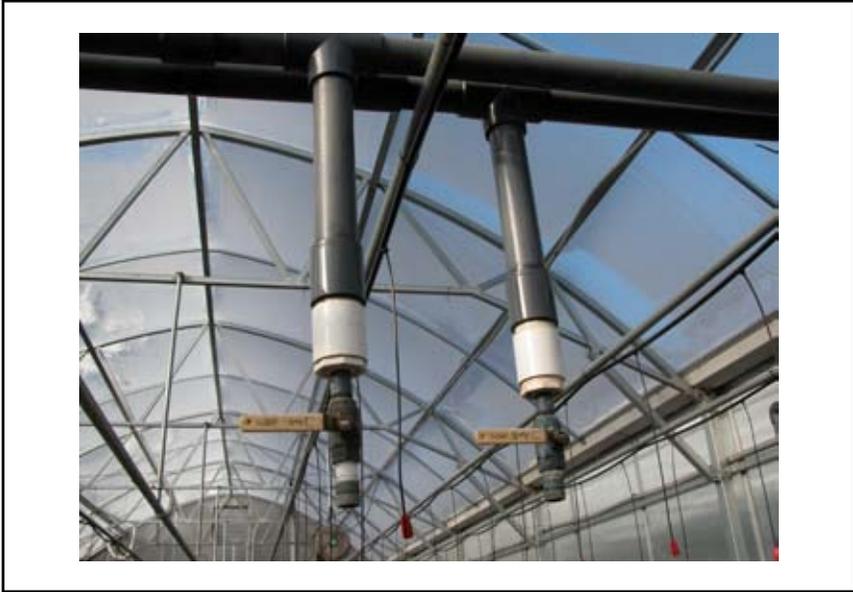
Figure 5. Schedule 80 PVC will not prevent algae growth inside irrigation lines.

Understanding the Enemy. I have heard the following advice regularly in conversations about irrigation systems. Don't use Schedule 40 PVC in the greenhouse because its white construction allows sunlight to penetrate, which allows algae to grow inside the pipe. Use schedule 80 PVC instead (Fig. 5), because it's thicker, gray construction prevents sunlight penetration, which prevents algae from growing. For growers who have followed this advice; Schedule 80 PVC pipe and fittings cost between two to three times as much as schedule 40. Other growers have told me that they used to paint their irrigation lines black for a similar reason. While the logic seems sound, read on to learn why adopting either of these practices amounts to nothing more than throwing money and time down the drain.

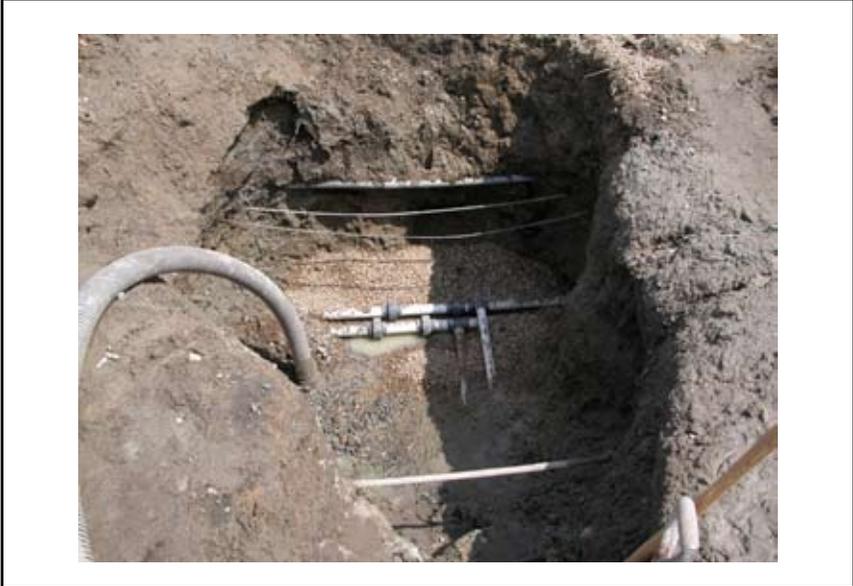
Two years ago I was in a 5-ft deep ditch (Fig. 6) cutting into 2-inch water and fertilizer mains to service a new greenhouse. Upon cutting through the fertilizer line I was left scratching my head in bewilderment. That fertilizer main was lined with the greenest layer of algae imaginable, 5-ft underground in complete darkness.

Figure 6. Underground clear water and fertilizer mains, which were cut to show algae and biofilm growth in the absence of sunlight.

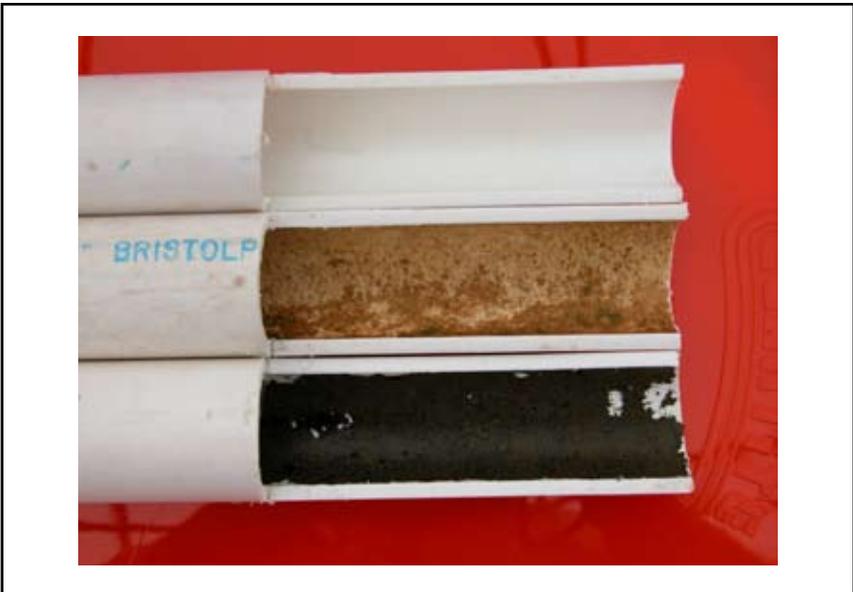
Figure 7. Longitudinally cut PVC mains; top section is new, middle section carries clear water, bottom section carries fertilizer. Note discolored biofilm layer in clear section and algae dominated layer in bottom section.

line and, while it was not lined with green algae, it was lined with a distinctive brown deposit. I saved samples of each pipe and cut them longitudinally to document my finding in a picture. In Fig. 7, the top section of pipe is new, the middle section is the clear water line, and the bottom section is the fertilizer line.

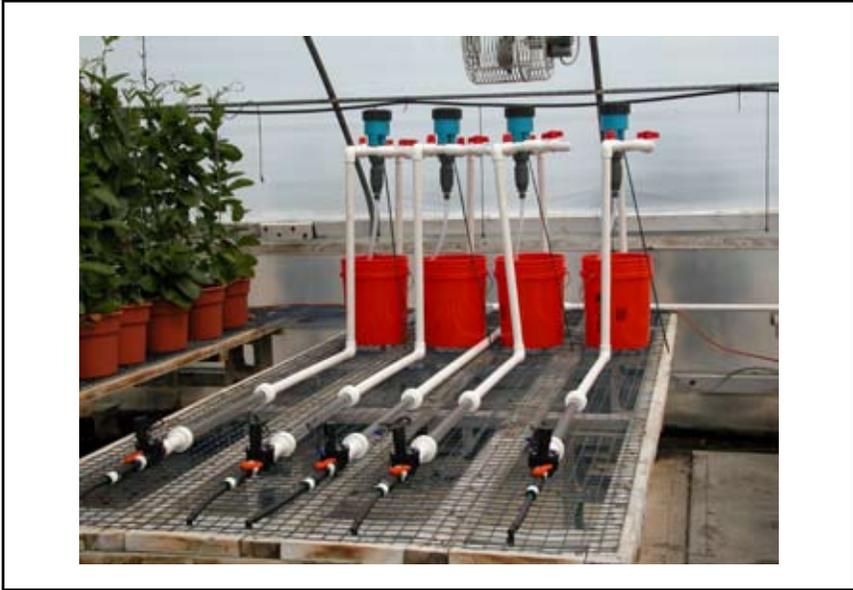
Figure 8. Experimental irrigation matrix for researching biofilm and algae in irrigation lines.

The Research. An experimental irrigation system was designed to allow us to research a new product, Selectroicide™ brand chlorine dioxide. The accompanying pictures on the right show the manifold system (Fig. 8). Four independent zones each included a dedicated Dosatron injector. A fifth zone was installed without an injector to serve as a control. Sections of clear PVC pipe in each zone allowed us to see algae as it grew in the pipes. It also allowed us to take pictures of how well various treatments killed the algae lining the pipes.

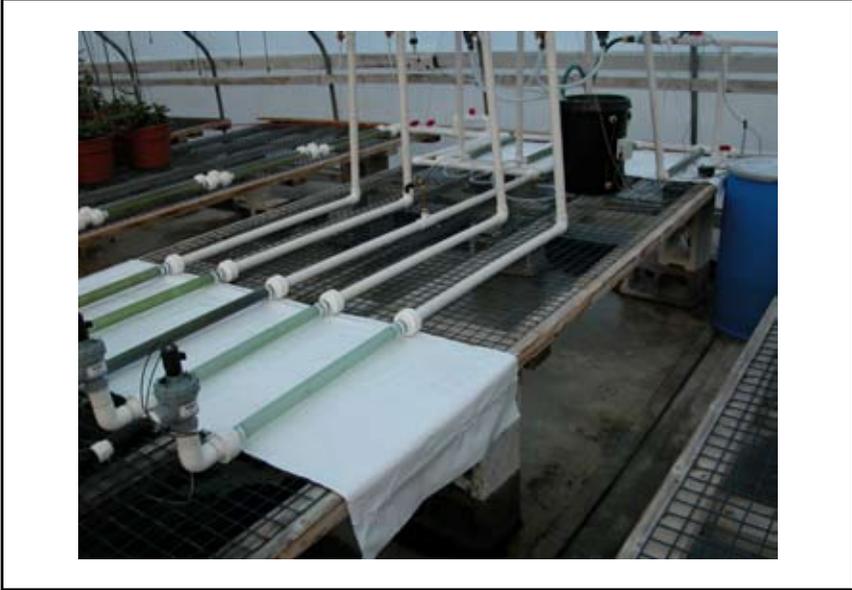
Figure 9. Clear sections of PVC installed to view algae and biofilm development.

Clear sections of pipe were also installed before the injectors to confirm that the lines were contaminated with algae during the time that the various chlorine dioxide treatments were occurring. These sections are visible in Figure 9. Our strategy was simple: if the water before the injector was green and the water after the injector was clean...we had a winning treatment. A common, constant fertilizer solution of 200 ppm nitrogen was used during the experiments.

Shock Treatment. Within weeks after installation a dark green layer of algae formed inside the clear sections of the manifold (Fig. 9). The first series of experiments was designed to determine how a contaminated irrigation line could be shocked to kill and strip algae and slime from the line.

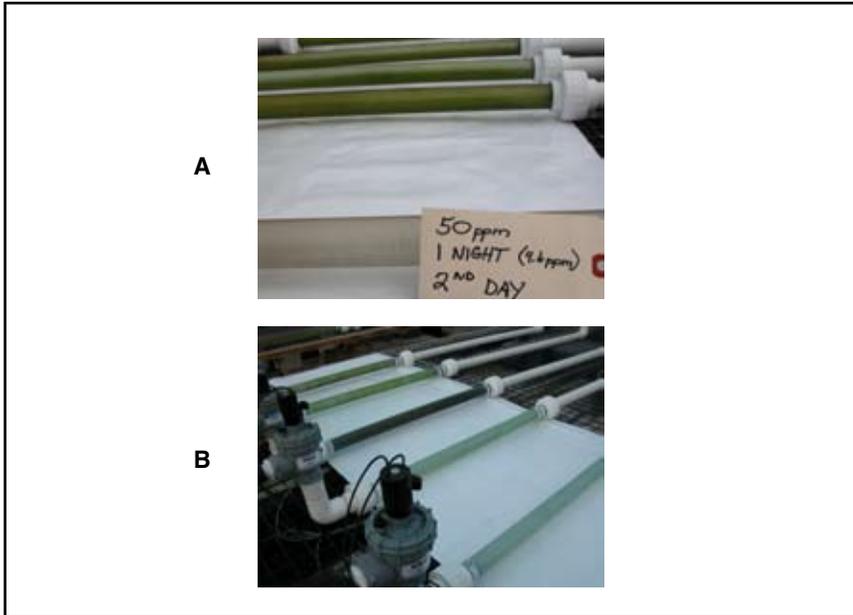
Figure 10A shows our first results. The clear section of pipe in the foreground received an overnight shock treatment of 50 ppm chlorine dioxide. The pipe was filled or “charged” at the end of the day and left that way overnight. The line was flushed the following morning prior to taking the picture. The green pipes in the upper portion of Fig. 10B were not treated. The treated pipe was just as green as these before the chlorine dioxide shock treatment was made. Needless to say, we were quite pleased with the results.

In the next step we repeated the overnight shock treatment to determine if additional shock treatments would be beneficial. Figure 10B shows one such experiment where different concentrations and number of overnight exposures were studied. The untreated control line is the dark green line in the center. Two consecutive, overnight shock treatments of 50 ppm provided excellent removal of algae and slime inside the lines. Shocking for more than two nights did not provide additional benefit.

Figure 10A & 10B. Top image showing clear section of line following shock treatment with Selectroicide. Bottom image showing various treatments with untreated control line in center. Note algae contamination in center line.

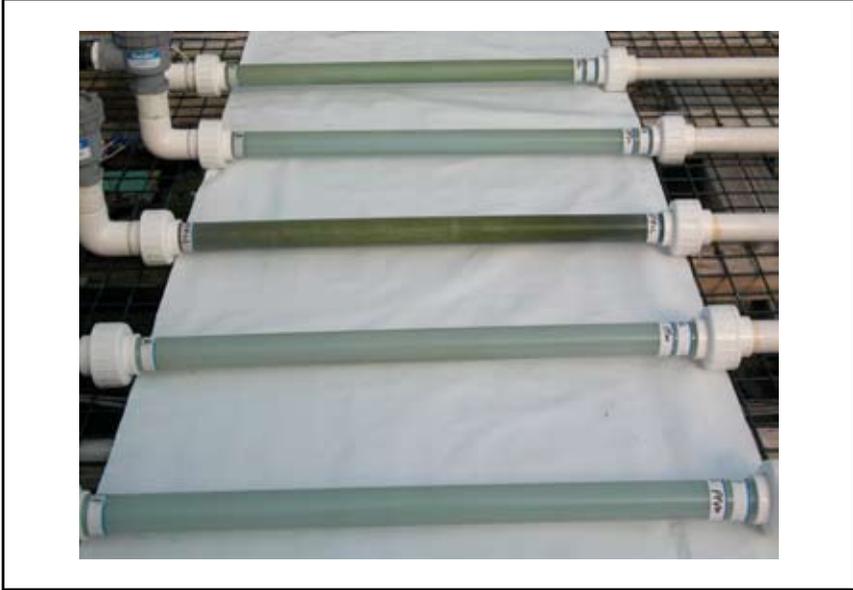
Figure 11 shows results of an experiment, which began with two consecutive overnight shocks of 50 ppm to ensure that all lines, including the center control line, were clean. Following the shock treatments ultra-low, continuous injection of chlorine dioxide started. Concentrations included, from top to bottom: 0.1, 0.25, control, 1.0, and 2.0 ppm, respectively. The picture was taken 12 weeks into treatment. Notice that the control line became dark green with re-established algae. Note also that the lowest concentration of 0.1 ppm (top line), while not nearly as green as the control, shows visible signs of the return of algae. Concentrations of 0.25 and higher all prevented re-establishment of algae. Based on these and other results, our recommended continuous concentration will be as little as 0.25 ppm following periodic shock treatments to keep the irrigation system and water algae free.

Figure 11. Clear sections of lines following continuous injection of Selectroicide with untreated control in center.

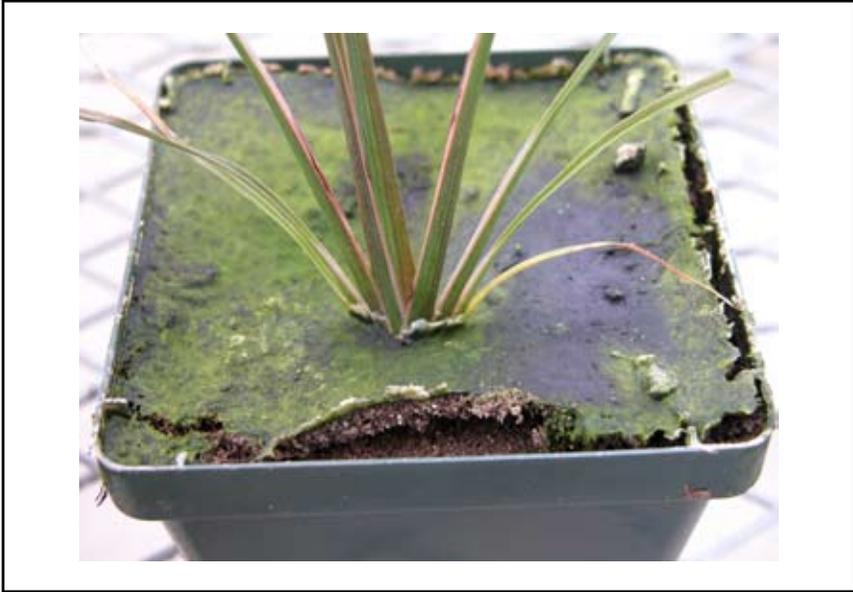
The curling mat of algae on this long-term crop speaks loudly about its water-repelling characteristic (Fig. 12). When developed sufficiently, it can be peeled off the growing surface in one piece. Notice also, just below the algae mat, that the growing mix is clean and fresh. In this environment, no sun...no algae.

Figure 12. Crusted, water repelling algae mat on growing medium surface.
