Replanting for the Future: Environmental Restoration and a Look at What Is Happening in Tauranga City®

Mark Dean

Naturally Native New Zealand Plants Ltd, Gamman Mill Rd, RD 3, Tauranga

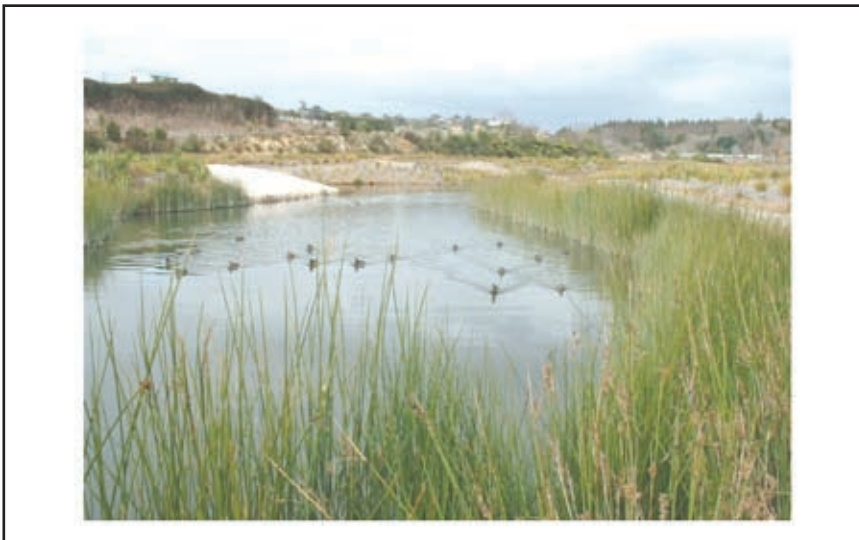
Figure 1. Matua storm water pond 1 year after planting.

Matua Salt Marsh (Fig. 1) is located in Tauranga City in the suburb of Otumoetai on the edge of an inlet facing to the west. Immediately adjacent to the estuary, an area of approximately 5 ha, comprising unused rank *Paspalum* pasture and weeds, was developed into two storm water retention ponds. The ponds were designed to filter storm water through two wetlands before it entered the rather delicate estuarine environment in Tauranga Harbour.

This project commenced in 2001 when seed was first collected. The ponds were constructed during January and February 2002 (summer). Once the earthworks had been completed in May 2002 the planting contractors that were employed by the nursery started work spreading mulch made from chipped waste wood. This was first spread over the site using a small excavator, as the soil was so wet it was difficult for other machinery to move over the site. Planting was done through the mulch. Wetland plants were placed in drifts along the edges of the two ponds. Apart from problems with Pukekoes (swamp hens) pulling out the newly planted rushes, the wetland plants established very easily and grew quickly. An island created in

the middle of the main pond as a wildlife refuge proved to be a planting headache. Water levels rose faster than anticipated, cutting access, which necessitated the use of a boat to transport plants to the island. Children from the three local schools were invited to participate in the planting in an effort to reduce vandalism. This strategy worked well and the project experienced few such problems. One year later the wetland plants had established very well. By Winter 2004 the two ponds were starting to take on a very natural effect with a variety of wildlife present.

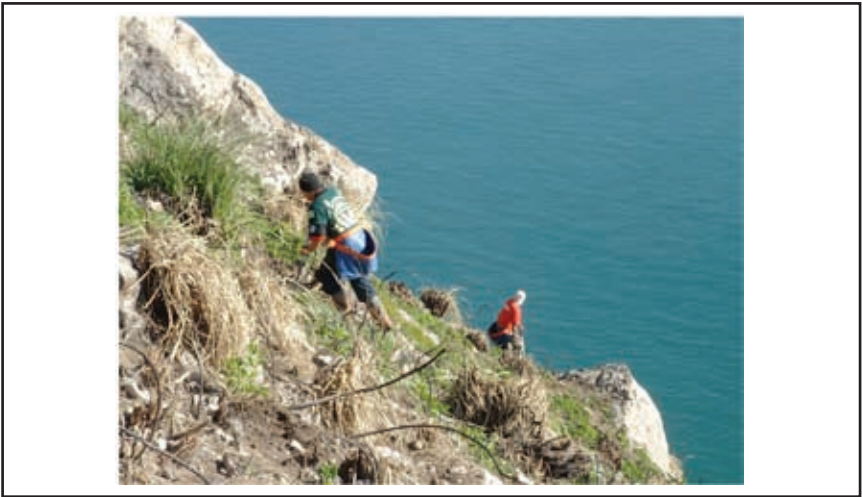
Figure 3. Planting above the cliffs on Mauao's north face.

Access was a major problem (Fig. 3). Plants were taken to the top of Mauao by four-wheel drive vehicle to the summit and then sent down a chute that was constructed to slide the plants to the various levels at which they were to be planted. On a planting site such as this safety is a major issue and ropes were rigged to aid the forestry planters, who were used to plant over 3000 plants in 2 cleared days. A similar operation has seen the company plant 20,000 plants on the eastern face of Mauao this year.

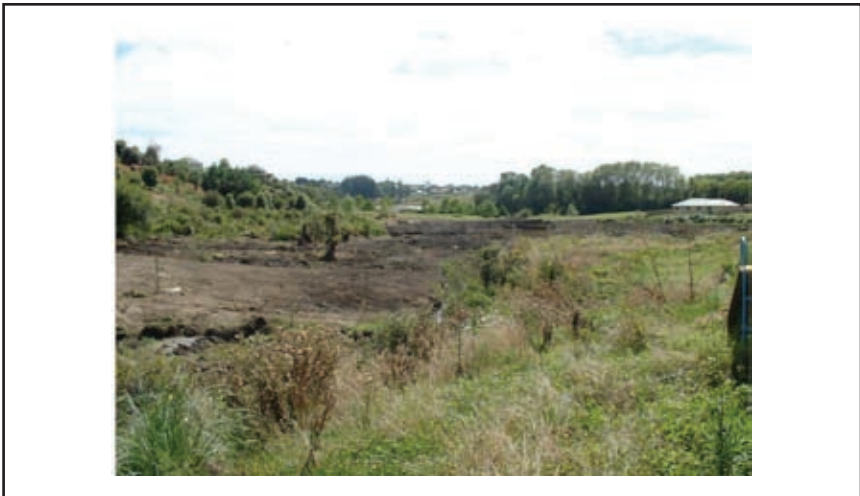
Figure 4. Before Millbrook wetland development 2003–2005.

In 2003 Tauranga City storm water engineers constructed a retention pond in a gully that was previously filled with grey willow. The willow was cleared using an excavator and the logs were buried during the construction process. Earthworks disturbed much of the site during the building of the pond, which made planting and subsequent plant establishment difficult (Fig. 4). However 2 years later the site has already established vegetation and wetland species successfully line the fringes of the pond (Fig. 5).

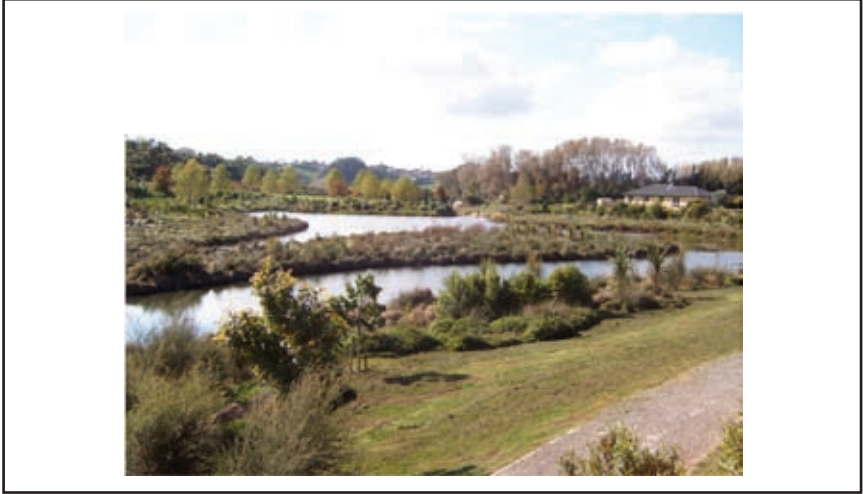
Figure 5. After Millbrook wetland development 2003–2005.

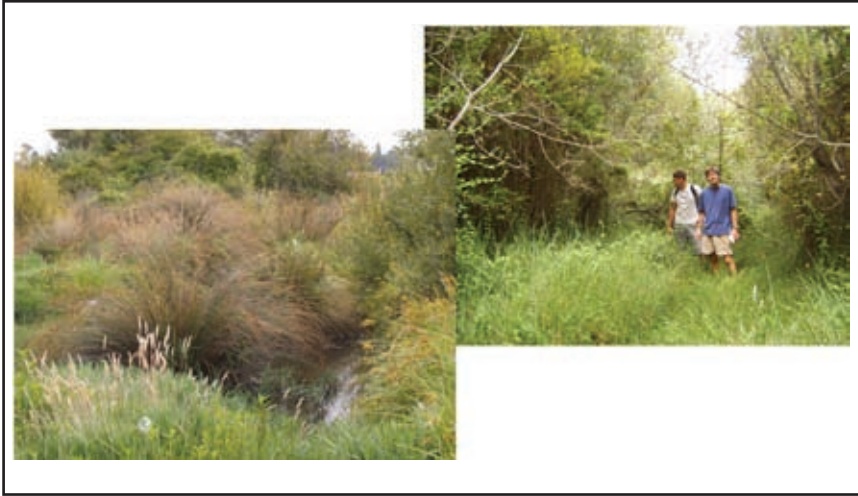
Figure 7. Vegetation types in the Kopurererua Valley.

Currently the valley has a variety of eco-systems including very degraded willow infested areas, open wetlands that have been grazed by stock for many years, and dry margins where tree ferns grow freely (Fig. 7).

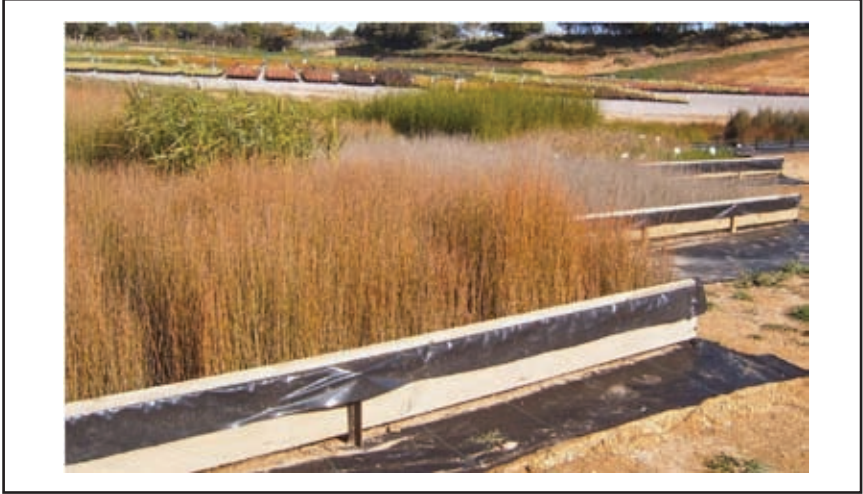
Figure 8. Wetland beds for growing wetland species.

Specialist Wetland Plants. Plants for wetlands are being grown for this project in specially constructed wetland beds at the Naturally Natives' nurseries in Tauranga and Whakatane. These beds allow the water level to be controlled throughout the growing process (Fig. 8).

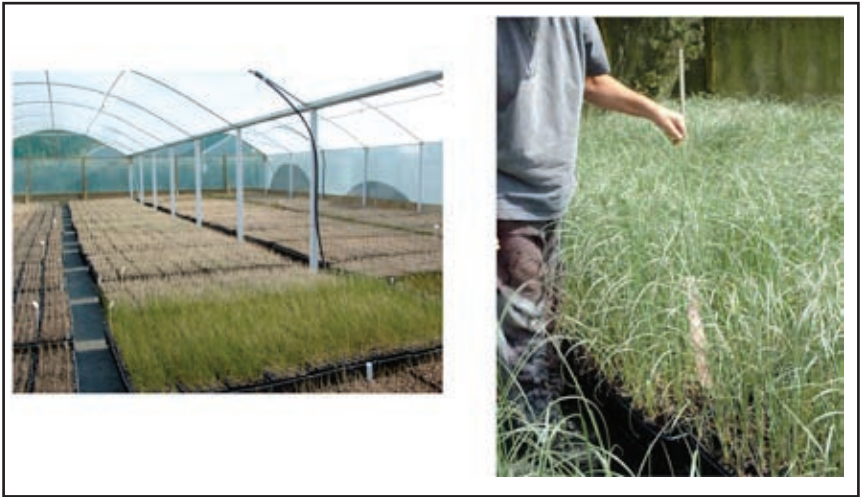
Figure 9. Spinifex production at Whakatane Nursery.

Naturally Native is also involved in supplying spinifex (*Spinifex sericeus*) plants for coastal dune restoration throughout the North Island. The spinifex production is done at our Whakatane Nursery (Fig. 9). Methods for growing spinifex were developed in a co-operative research project with Forest Research from 1996–2000.

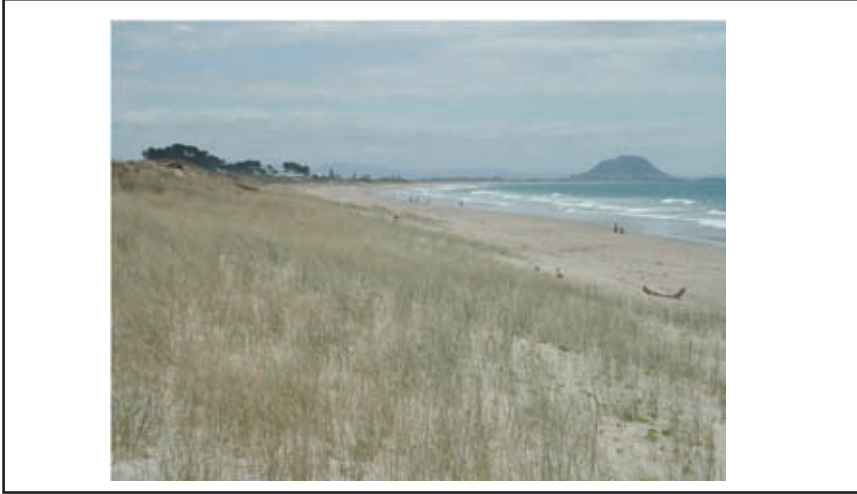
Figure 10. Replanted spiniflex dune at Papamoa — south east of Mt. Maunganui.

Spinifex has the ability to trap sand and so build beaches thus combating beach erosion. The effects of planting spinifex are quite dramatic. Some Tauranga and Bay

of Plenty beaches now have a significantly different profile since spinifex has been restored to the dune system (Fig. 10). Council sponsored community Coast Care groups receive the plants grown at the Naturally Native nursery and plant them out into the dunes during winter. Growth is fast and the results are dramatic.
