Recycled Water Quality Dynamics and Implications for Ornamental Crop Production[©]

Chuanxue Hong

Hampton Roads Agricultural Research and Extension Center, Virginia Tech, Virginia Beach,
Virginia 23455, USA

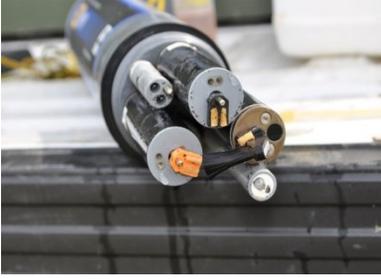
Fig. 1. A multiprobe Sonde set to continuously monitor water quality

A multiprobe Sonde (Fig. 1) was anchored in the middle of each selected pond and set to continuously record surface water quality. Water quality parameters monitored included temperature, pH, **oxidation-reduction potential (ORP)**, **electrical conductivity (EC)**, turbidity, **dissolved oxygen (DO)**, chlorophyll *a*, and Blue-green algae, plus the depth at which water quality data were taken. Recorded data were communicated directly from four Sondes in VA10, VA12, VA 21, and VA23, respectively, to an office computer via telemetry systems and Verizon satellites or manually downloaded from other Sondes. Sondes set for real-time data communication were programmed to record data every 15 minutes, while the others recorded data hourly.

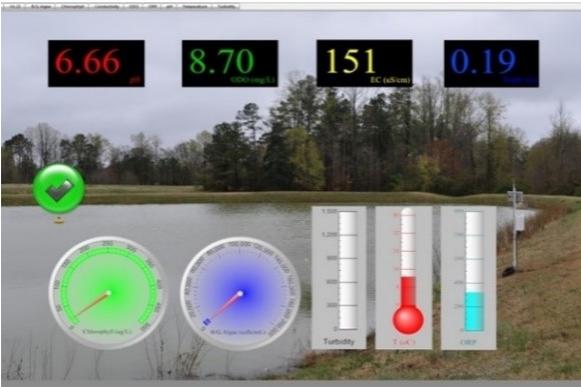
Fig. 2. Real-time data communication via a telemetry system and Verizon satellites

As shown in the computer screenshot (Fig. 2), the system was programmed to have a background photo showing a pond where water quality was being monitored and different gauges showing real-time water quality data in the pond with pH, DO, EC and depth on the top, while chlorophyll *a*, blue-green algae, turbidity, temperature, and ORP at the bottom. The gauge in the middle was a system status gauge; a green check indicates that the system works properly, while a red cross would mean that the system is out of service.
